CONSTRUCTION MONITORING & EVALUATION PROGRAM

(Reconstruction of Damaged Schools in Khyber Pakhtunkhwa)

MONTHLY PROGRESS REPORT # 13
APRIL, 2014

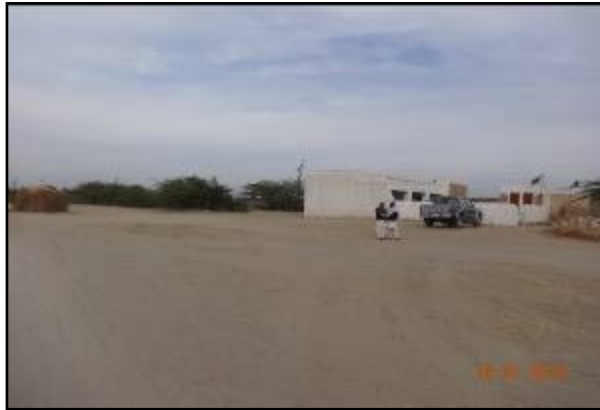
Overall view of damaged school

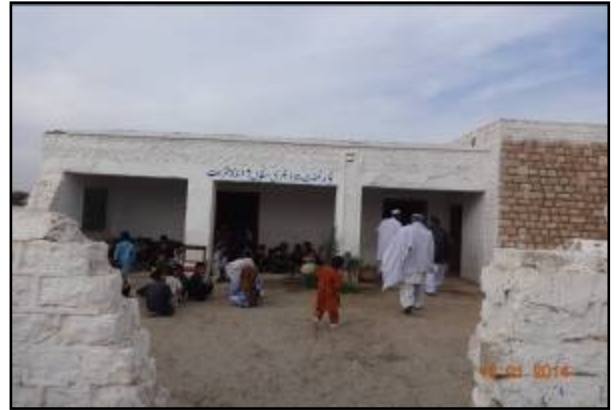
Front view of damaged school

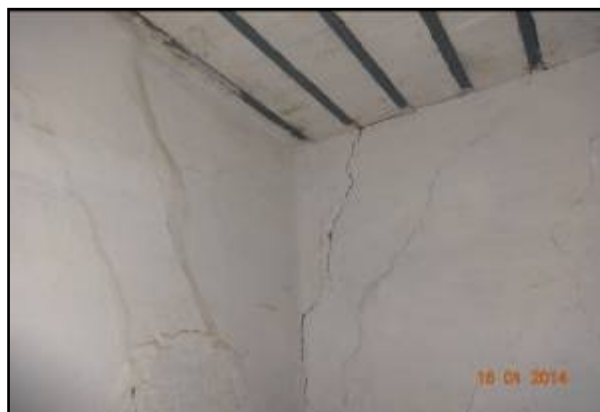
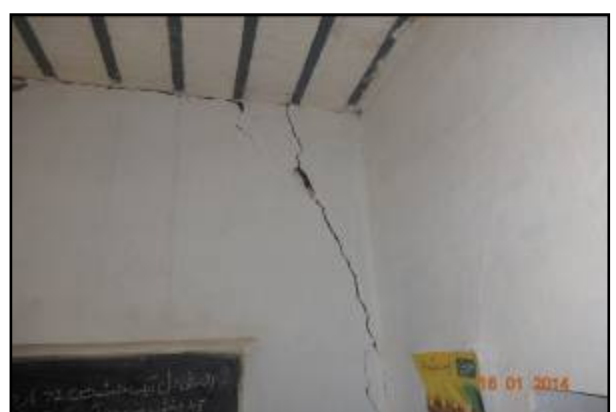
View of damaged class rooms

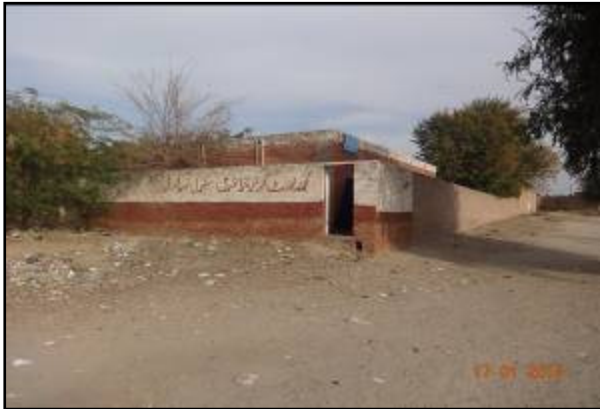
Main Entrance of the damaged school

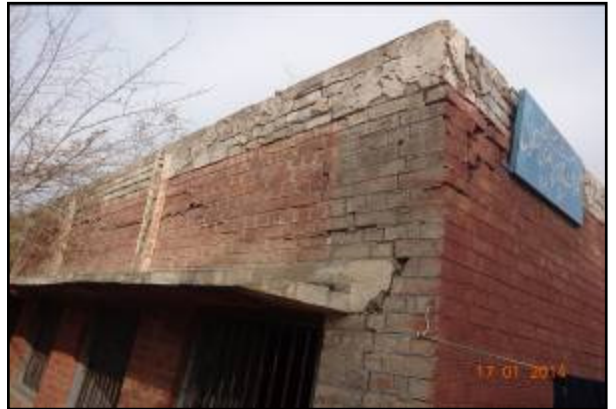
Another View of damaged school

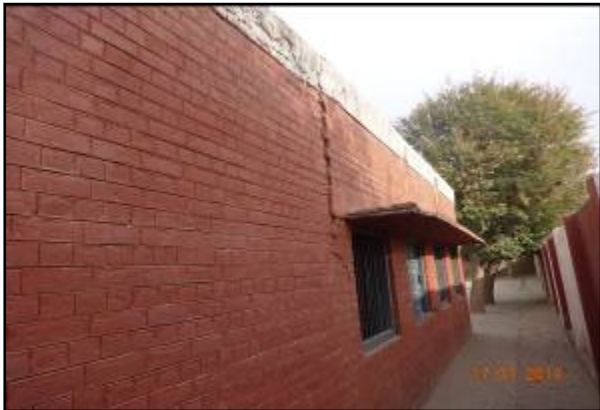
Side View of damaged school

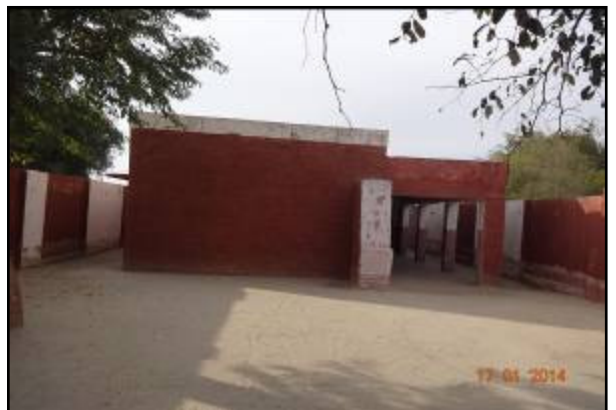
Another View of damaged school

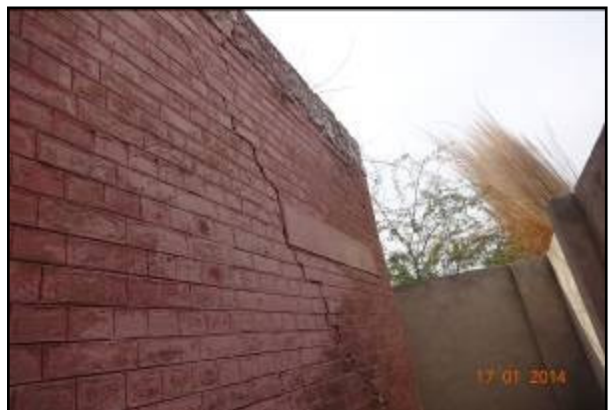
Visible Cracks

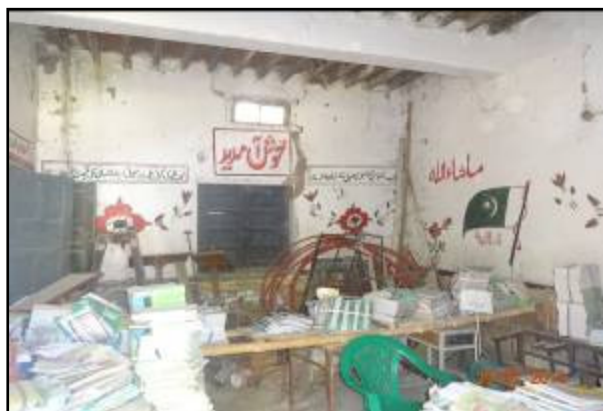
Inside Damaged Class Rooms

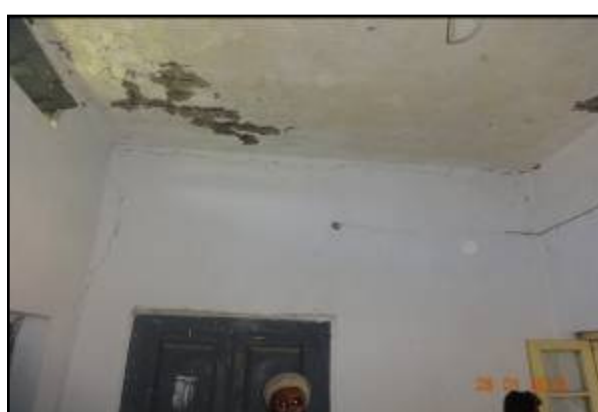
Inside Damaged Class Room

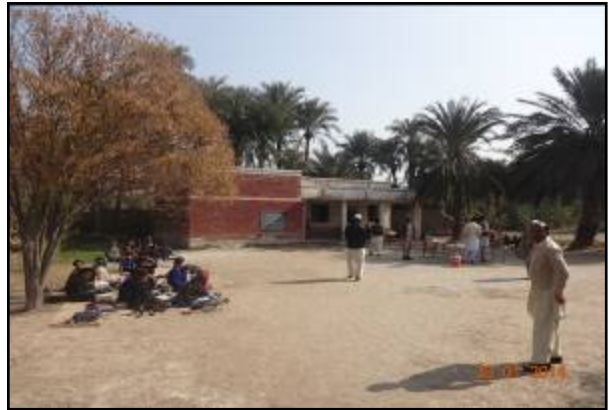
Front view of damaged school

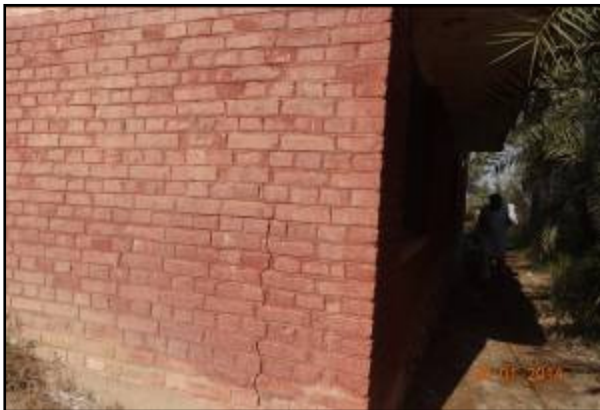
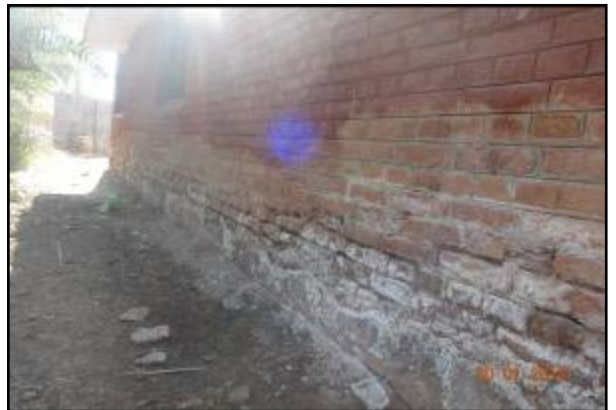
Side Views of Damaged School

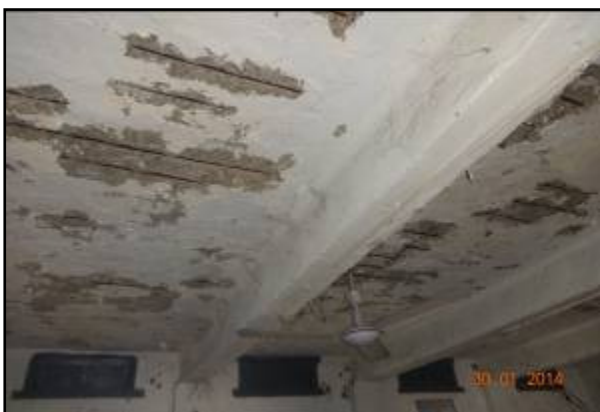
Damaged Slab

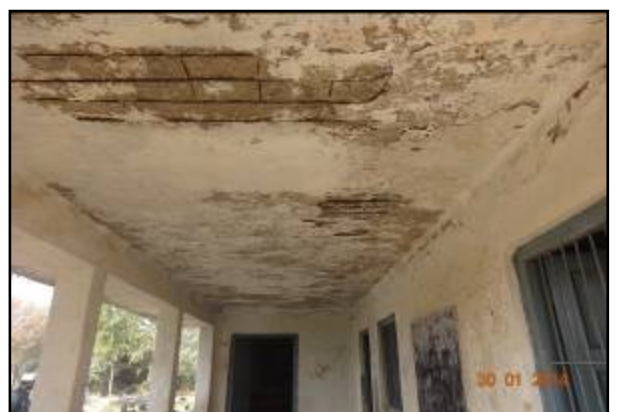
Damaged Verandah

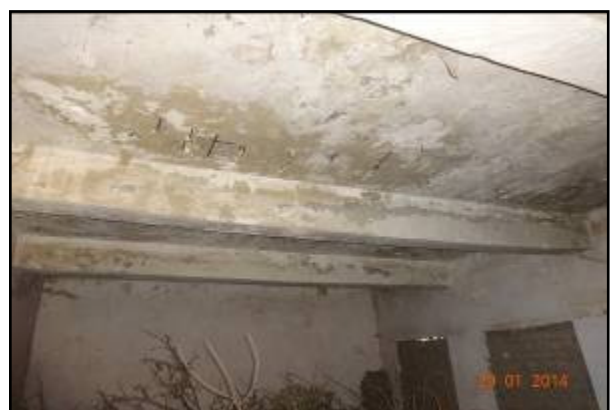
View of damaged slab

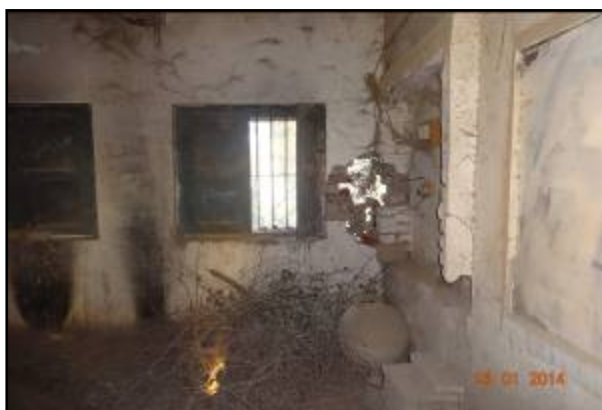
View of damaged class room

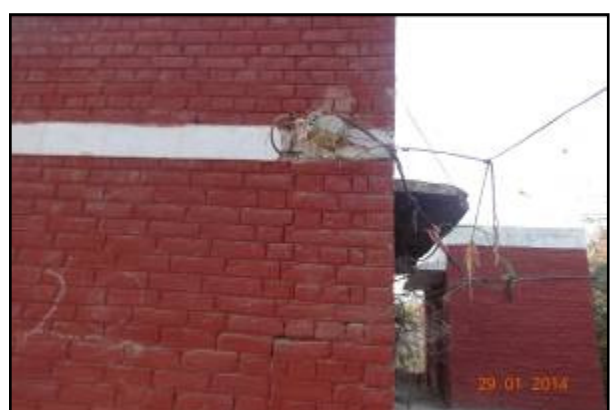
Side view of the damaged school

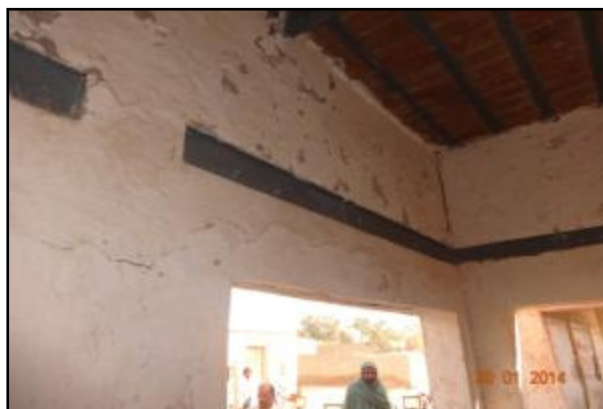
View of damaged verandah

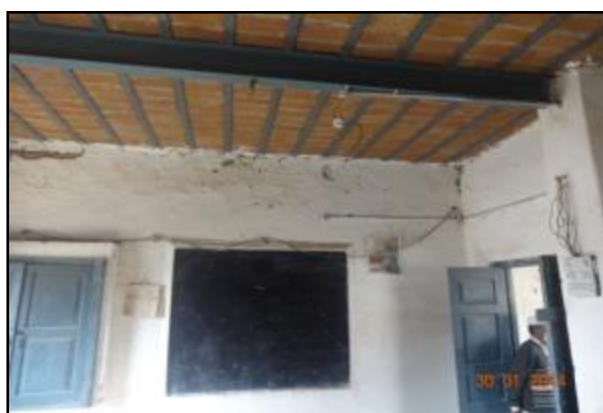
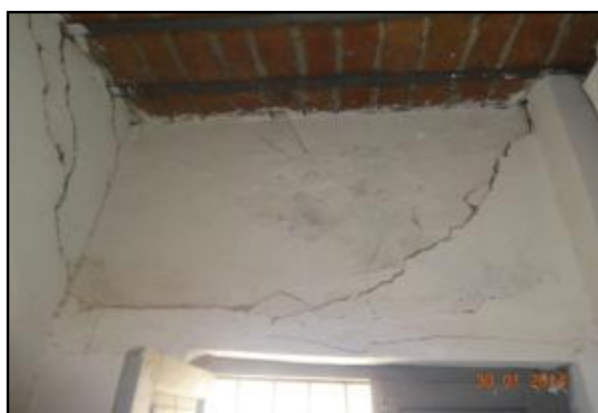
View of damaged class rooms

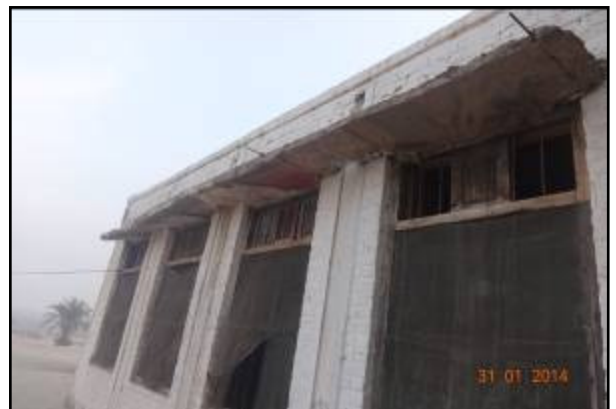
Rear view of damaged school

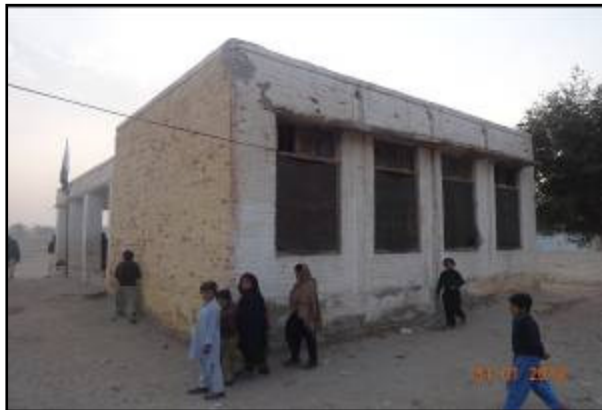
Side view of damaged school

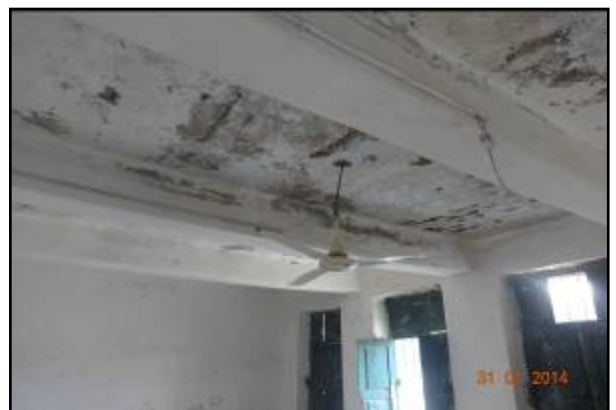
Inside damaged class room

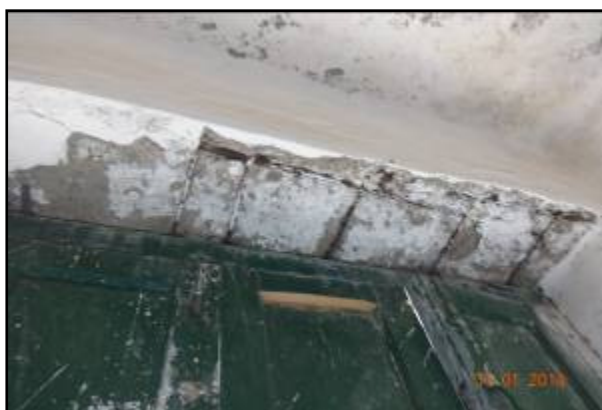
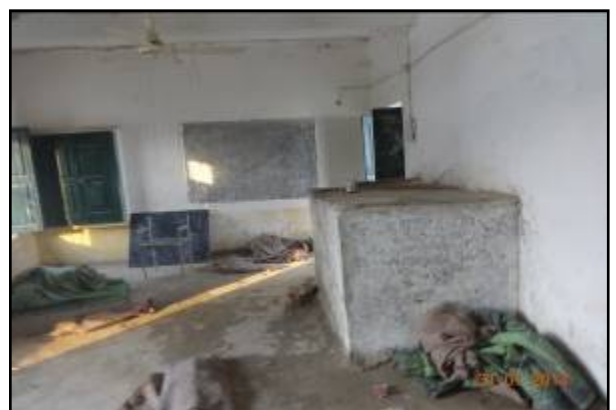
Inside damaged class room

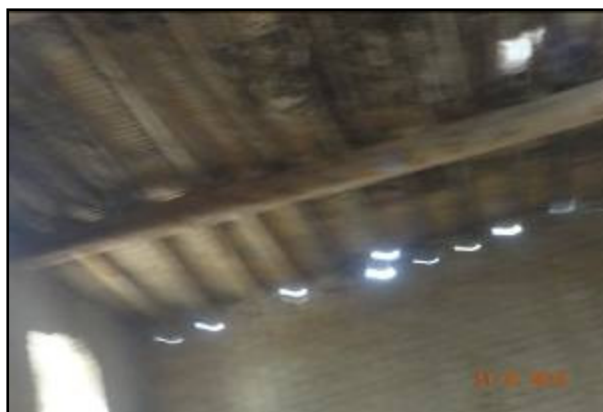
Damaged Class room

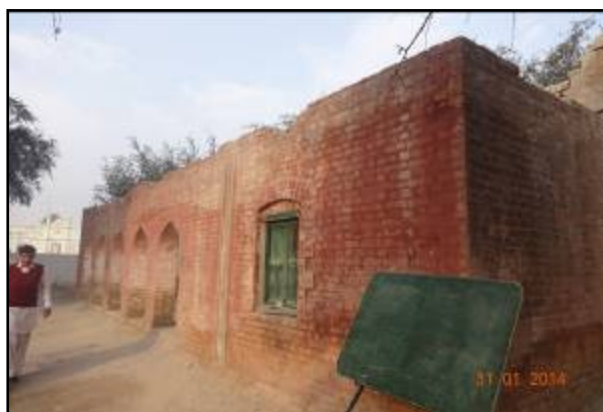
Side View of the damaged school

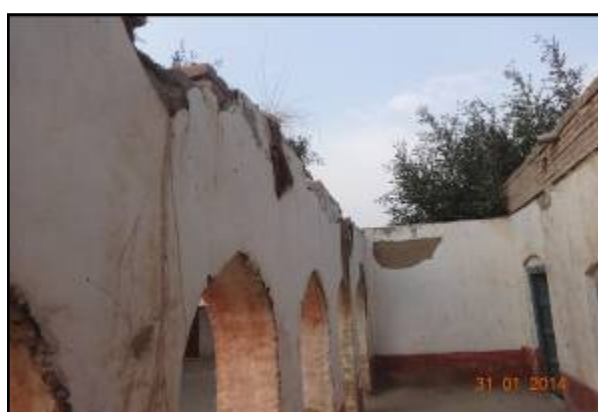
Damaged verandah

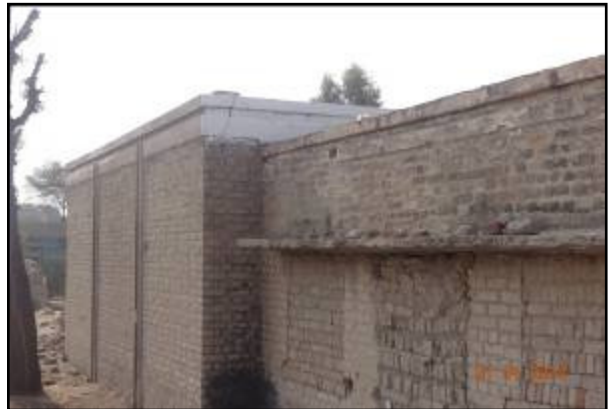
Rear View of the damaged school

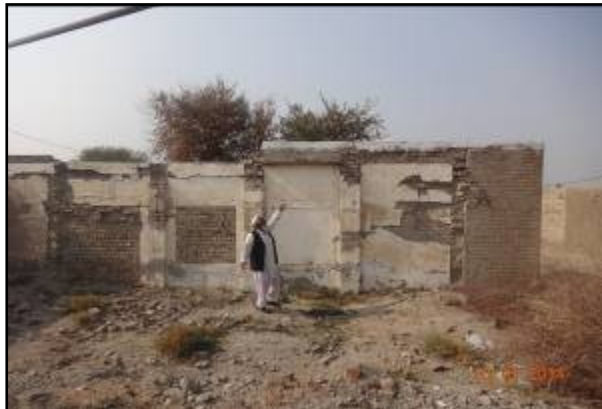
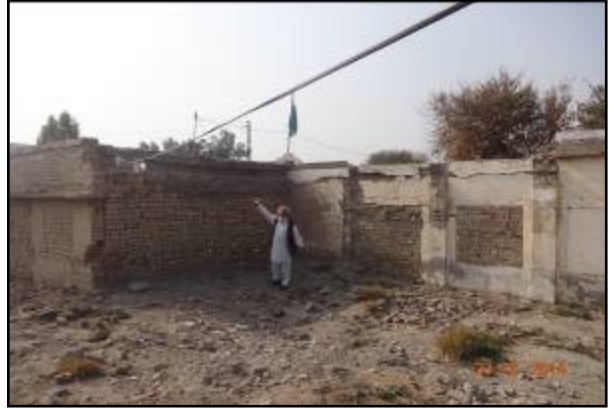
Views of the destroyed class room

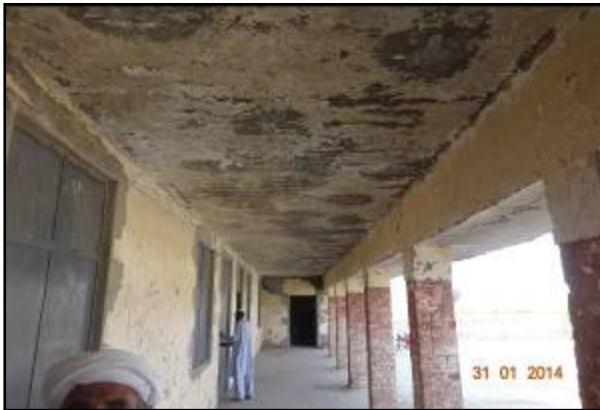
View of damaged Verandah

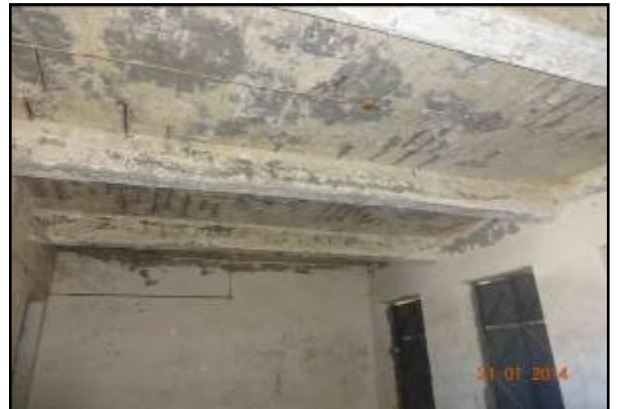
View of damaged slab of class room

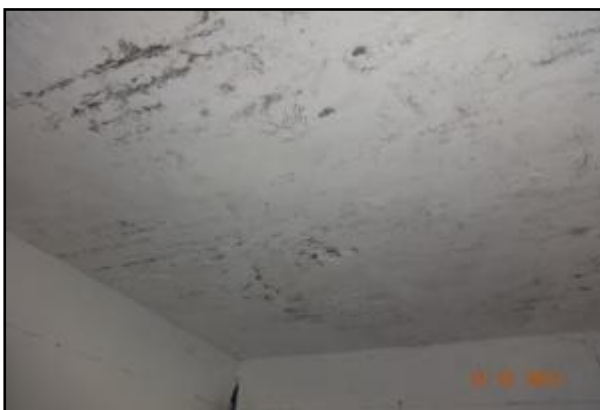
View of damaged Slab

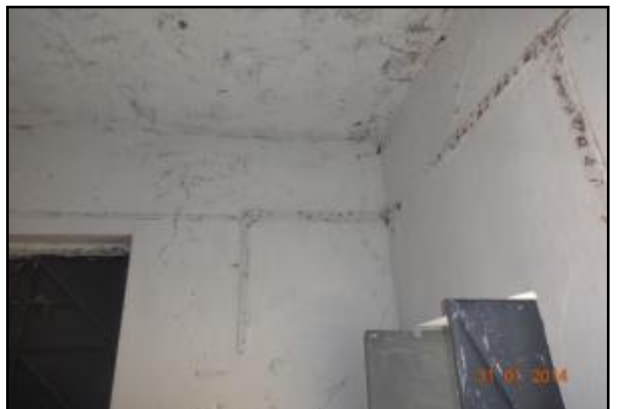
View of damaged class room

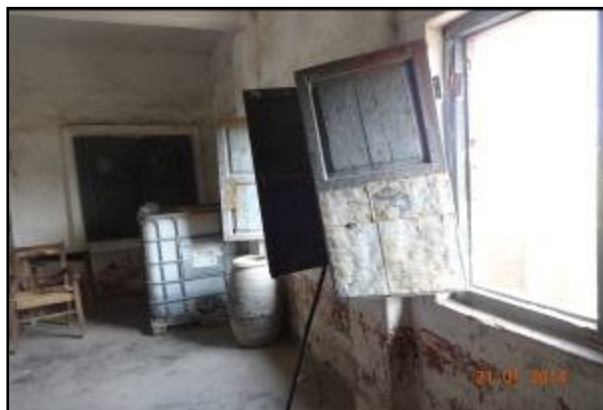
Class room needs renovation

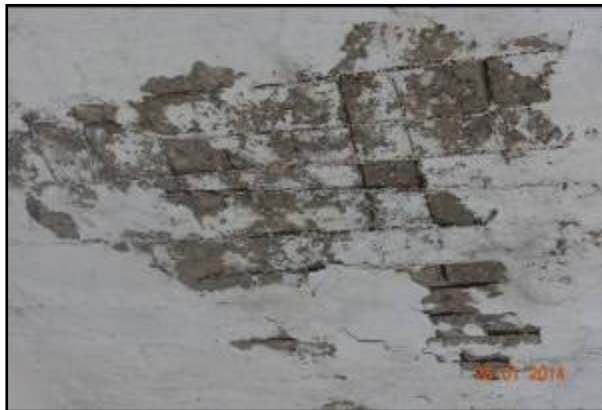
Damaged Slab

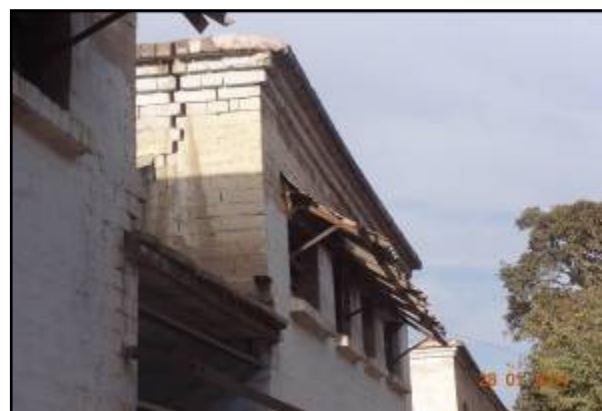
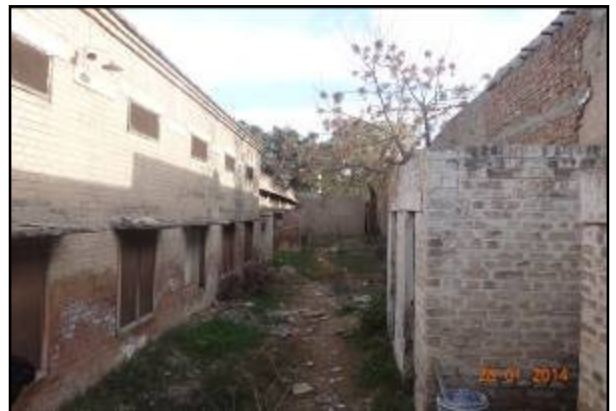
Side Views of damaged school buildings

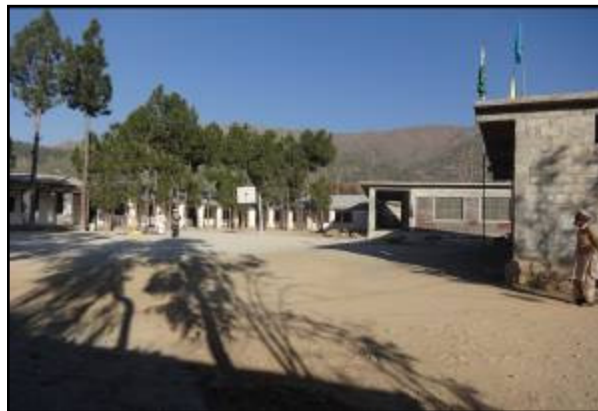
Overall View of the damaged school

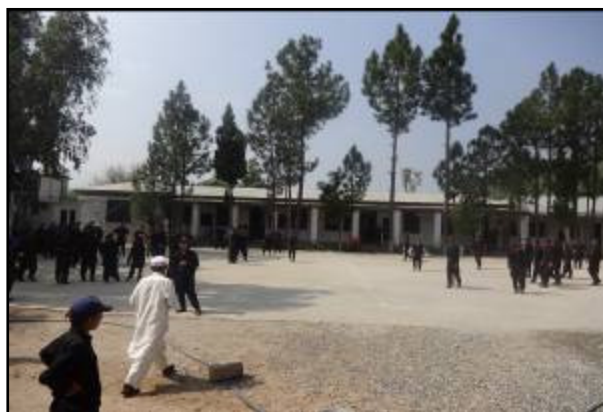
Front View of the damaged school

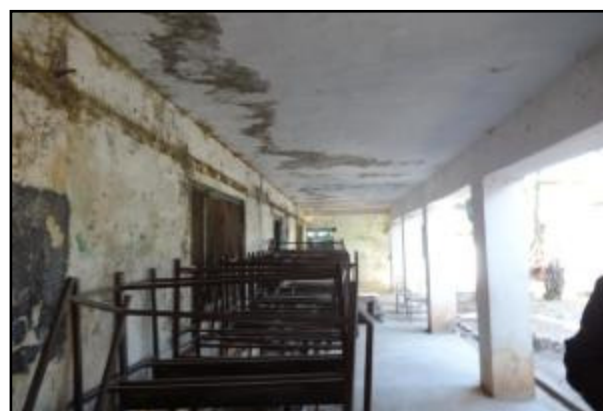
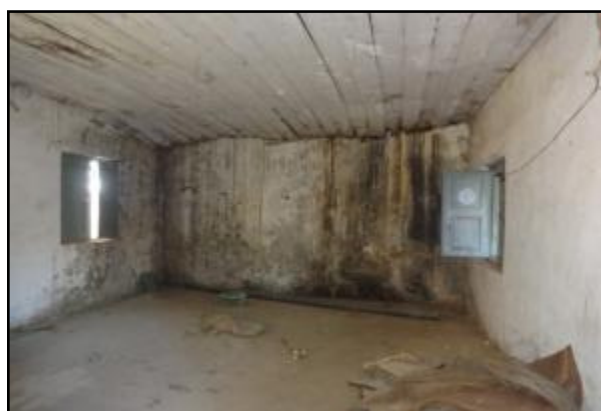
View of damaged Building

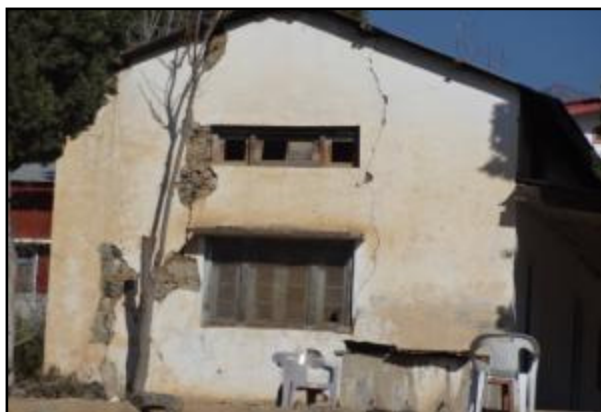
View of damaged room

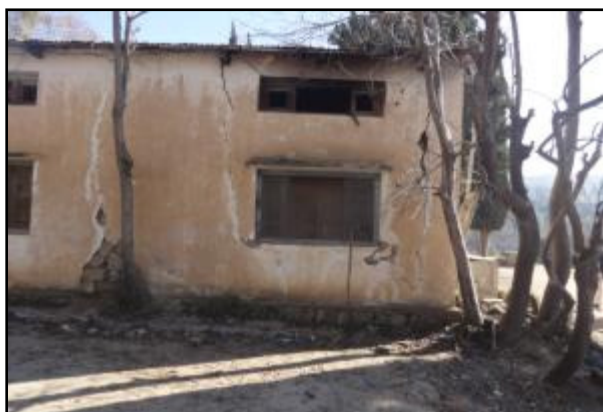
Another View of damaged Class room

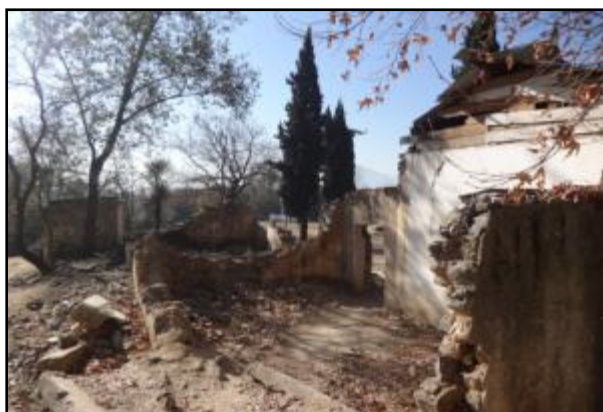
View of damaged building
